Wood Products Victoria Ltd

Guide to Assessment and Repair of Flood Damaged Timber and Timber Framed Houses

(15 February 2011)

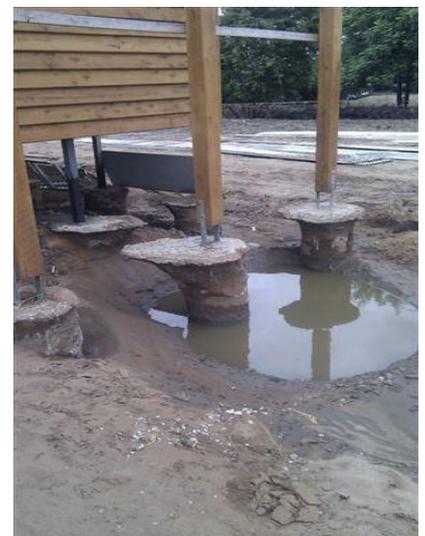
- Scoured out footings/foundations and supports (check that dried out mud/silt is not hiding damage)
- Cracked or broken members
- Loose joints and connections
- Adequate seating and bearing of members
- Gaps between support points and joints
- Damaged tie-down connections
- Damaged sheet bracing (lining materials)
- Damaged trusses and truss plates
- Truss plates not firmly seated in timber
- Girder trusses (trusses that support other trusses)

Footings scoured out by fast flowing water

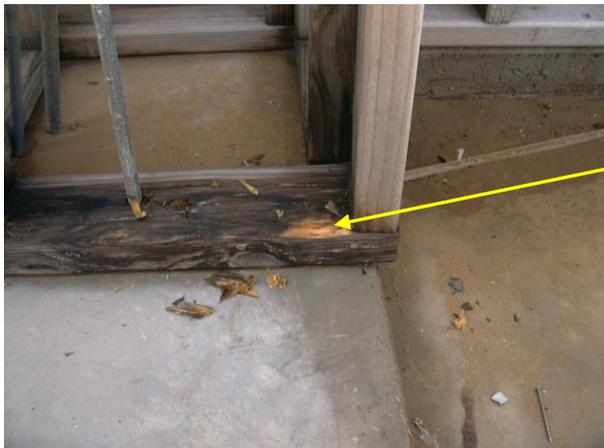
Although heavily discoloured with surface mould and blue stain, the pine timber is still sound as shown by scraping back the surface layer

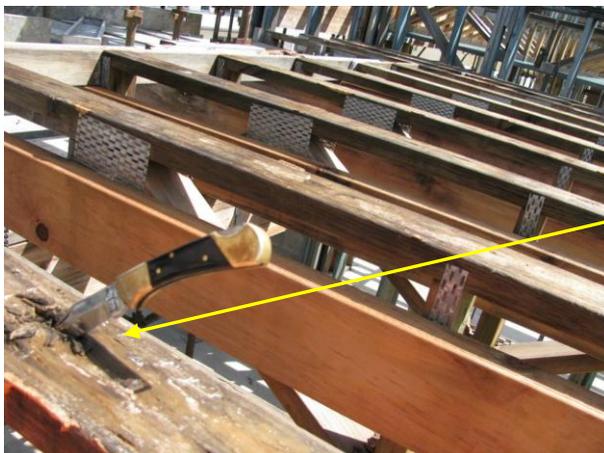
Decayed timber is soft and spongy and can easily be penetrated with a knife or screwdriver

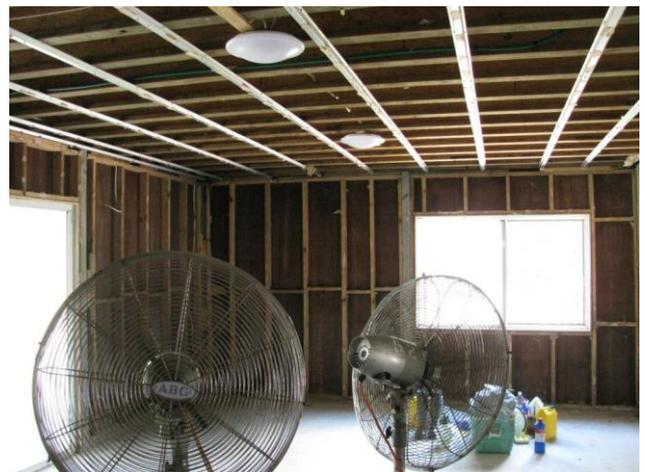
Irrespective of the need to access frames for cleaning etc, **most lining products** that have been inundated (T&G VJ, plasterboard, plywood, hardboard ('Masonite'), medium density fibreboard, etc) will need to be replaced.

Lining should be removed to at least 300mm above the highest level of inundation (or further if required for adequate re-instatement of the lining i.e. half wall height or full wall height). Inundated bulk (batts) wall or ceiling insulation will need to be removed and replaced during cleaning and repairs.

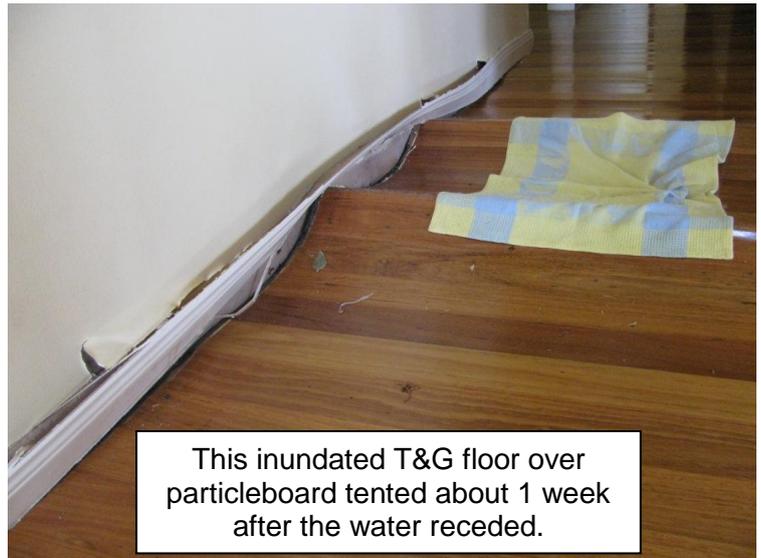
The flooring may continue to swell or expand across the boards for a period of time even after the water has subsided as moisture moves deeper into the timber. After cleaning, assess the extent of swelling and or tenting of boards (lifting off the supports). Check to see if there is still clearance between the edges of boards and the bottom plates of walls (usually under the skirting board) and to see if the flooring has expanded and started to push wall frames out at the bottom. If necessary relieve the pressure on walls by removing or cutting out perimeter boards. Eliminate any trip hazards that may have arisen due to tenting of boards or lifting of nails etc.

Allow the flooring a minimum of 4 months to dry out before re-assessing. Gaps between boards are highly likely to occur as the floor dries out, however the structural adequacy of the flooring is not likely to have been compromised and floors may be lived on in the meantime.

Following re-assessment, consideration can then be given to rectification in accordance with industry recommendations which may include the following options:-

- Re-sanding and polishing
- Overlaying with a new thinner overlay timber floor
- Replacing the floor with a new timber floor
- Installation of alternative floor coverings

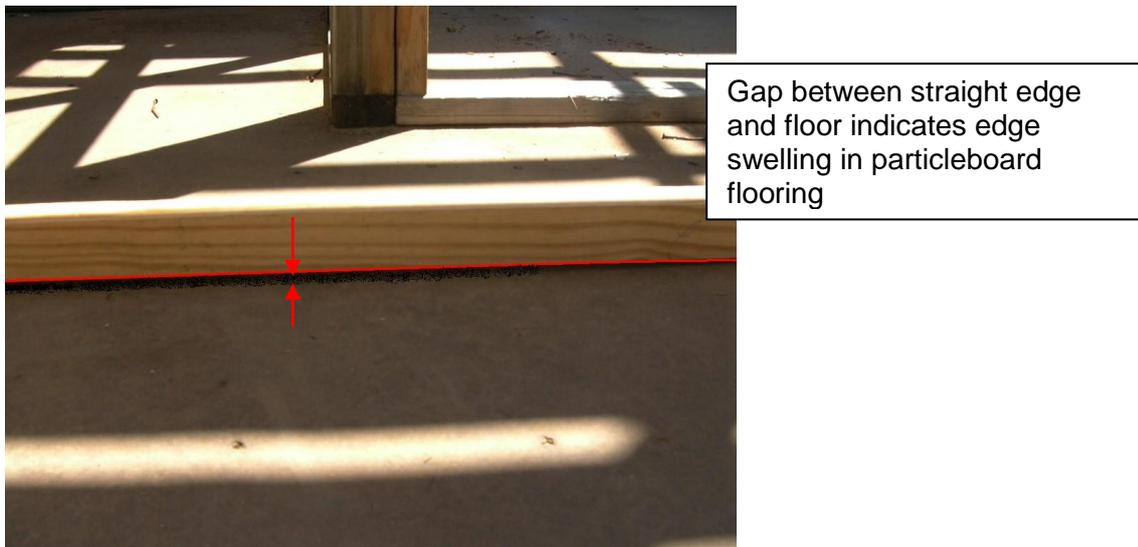
Allow the particleboard flooring a minimum of 4 months to dry out before re-assessing and any rectification that may be required. As a guide only, it is suggested that if sheet edges have swollen more than 5mm (i.e. would need to be sanded back by 5mm or more to get a flat floor) then the structural adequacy of the flooring has been compromised and needs rectification by either replacement or installation of a new structural floor over the existing particleboard.
