Wood Products Victoria Ltd

Guide to Assessment and Repair of Flood Damaged Timber and Timber Framed Houses

(15 February 2011)

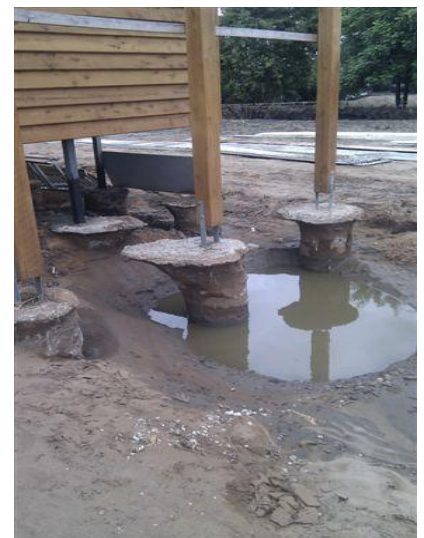
Footings scoured out by fast flowing water

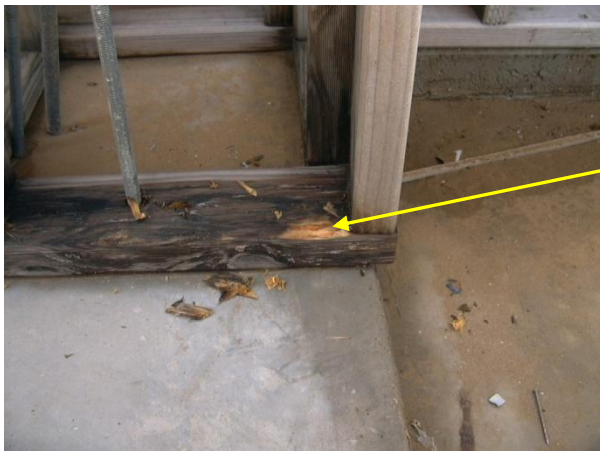
Although heavily discoloured with surface mould and blue stain, the pine timber is still sound as shown by scraping back the surface layer

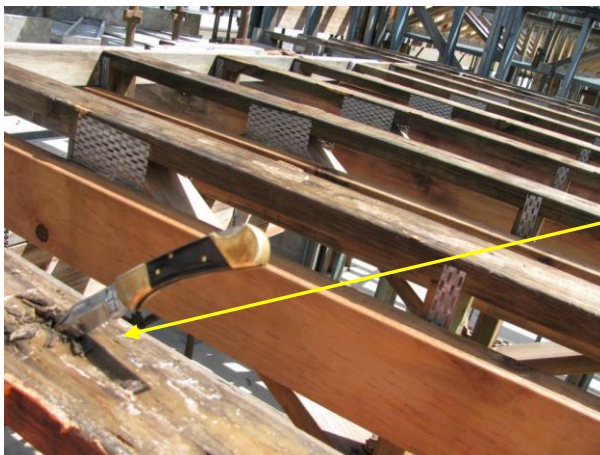
Decayed timber is soft and spongy and can easily be penetrated with a knife or screwdriver
