Wood Products Victoria Ltd

Guide to Assessment and Repair of Flood Damaged Timber and Timber Framed Houses

(15 February 2011)

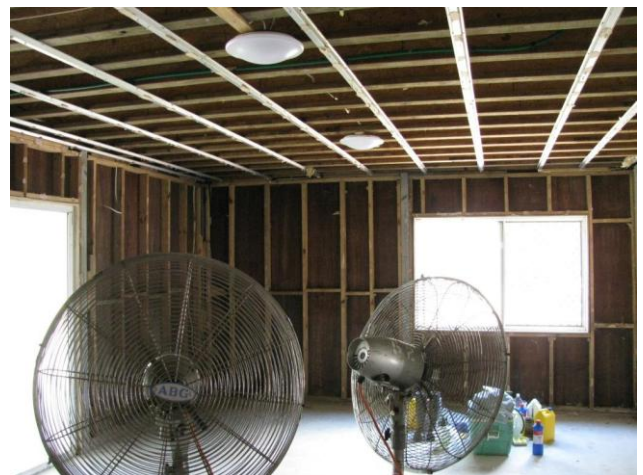
Irrespective of the need to access frames for cleaning etc, **most lining products** that have been inundated (T&G VJ, plasterboard, plywood, hardboard ('Masonite'), medium density fibreboard, etc) will need to be replaced.

Lining should be removed to at least 300mm above the highest level of inundation (or further if required for adequate re-instatement of the lining i.e. half wall height or full wall height). Inundated bulk (batts) wall or ceiling insulation will need to be removed and replaced during cleaning and repairs.

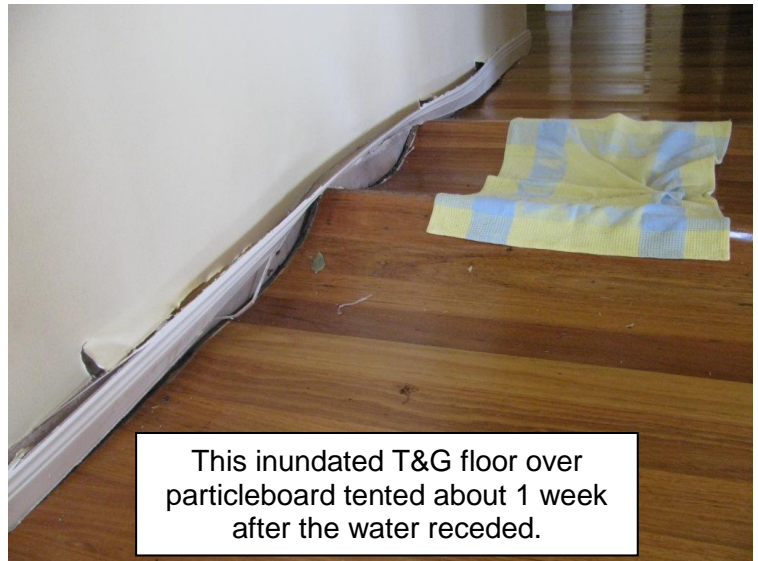
The flooring may continue to swell or expand across the boards for a period of time even after the water has subsided as moisture moves deeper into the timber. After cleaning, assess the extent of swelling and or tenting of boards (lifting off the supports). Check to see if there is still clearance between the edges of boards and the bottom plates of walls (usually under the skirting board) and to see if the flooring has expanded and started to push wall frames out at the bottom. If necessary relieve the pressure on walls by removing or cutting out perimeter boards. Eliminate any trip hazards that may have arisen due to tenting of boards or lifting of nails etc.

Allow the flooring a minimum of 4 months to dry out before re-assessing. Gaps between boards are highly likely to occur as the floor dries out, however the structural adequacy of the flooring is not likely to have been compromised and floors may be lived on in the meantime.

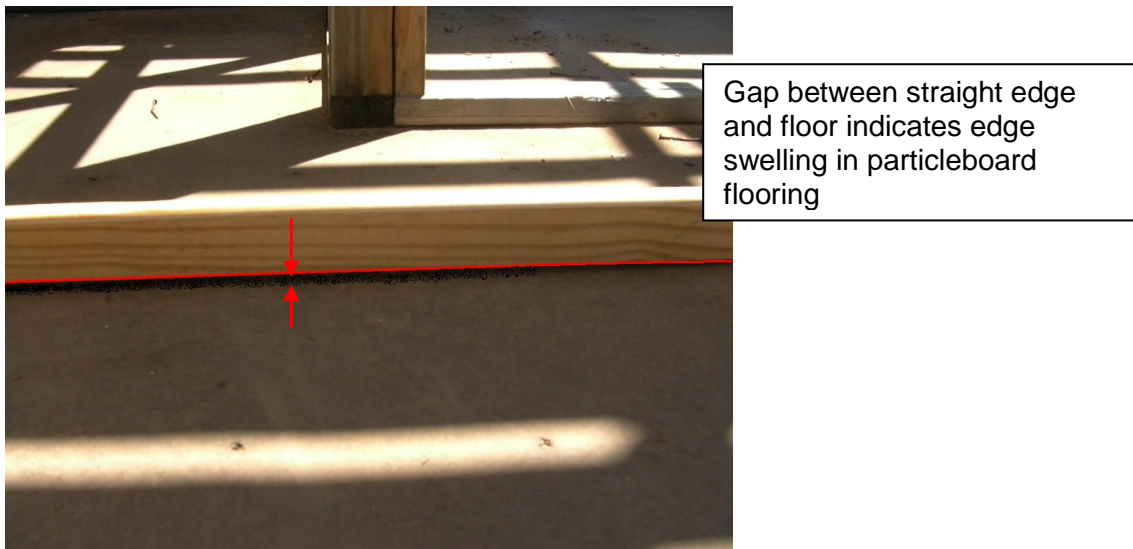
Allow the particleboard flooring a minimum of 4 months to dry out before re-assessing and any rectification that may be required. As a guide only, it is suggested that if sheet edges have swollen more than 5mm (i.e. would need to be sanded back by 5mm or more to get a flat floor) then the structural adequacy of the flooring has been compromised and needs rectification by either replacement or installation of a new structural floor over the existing particleboard.
